Existing Typical Almshouse Section

Proposed Typical Almshouse Section

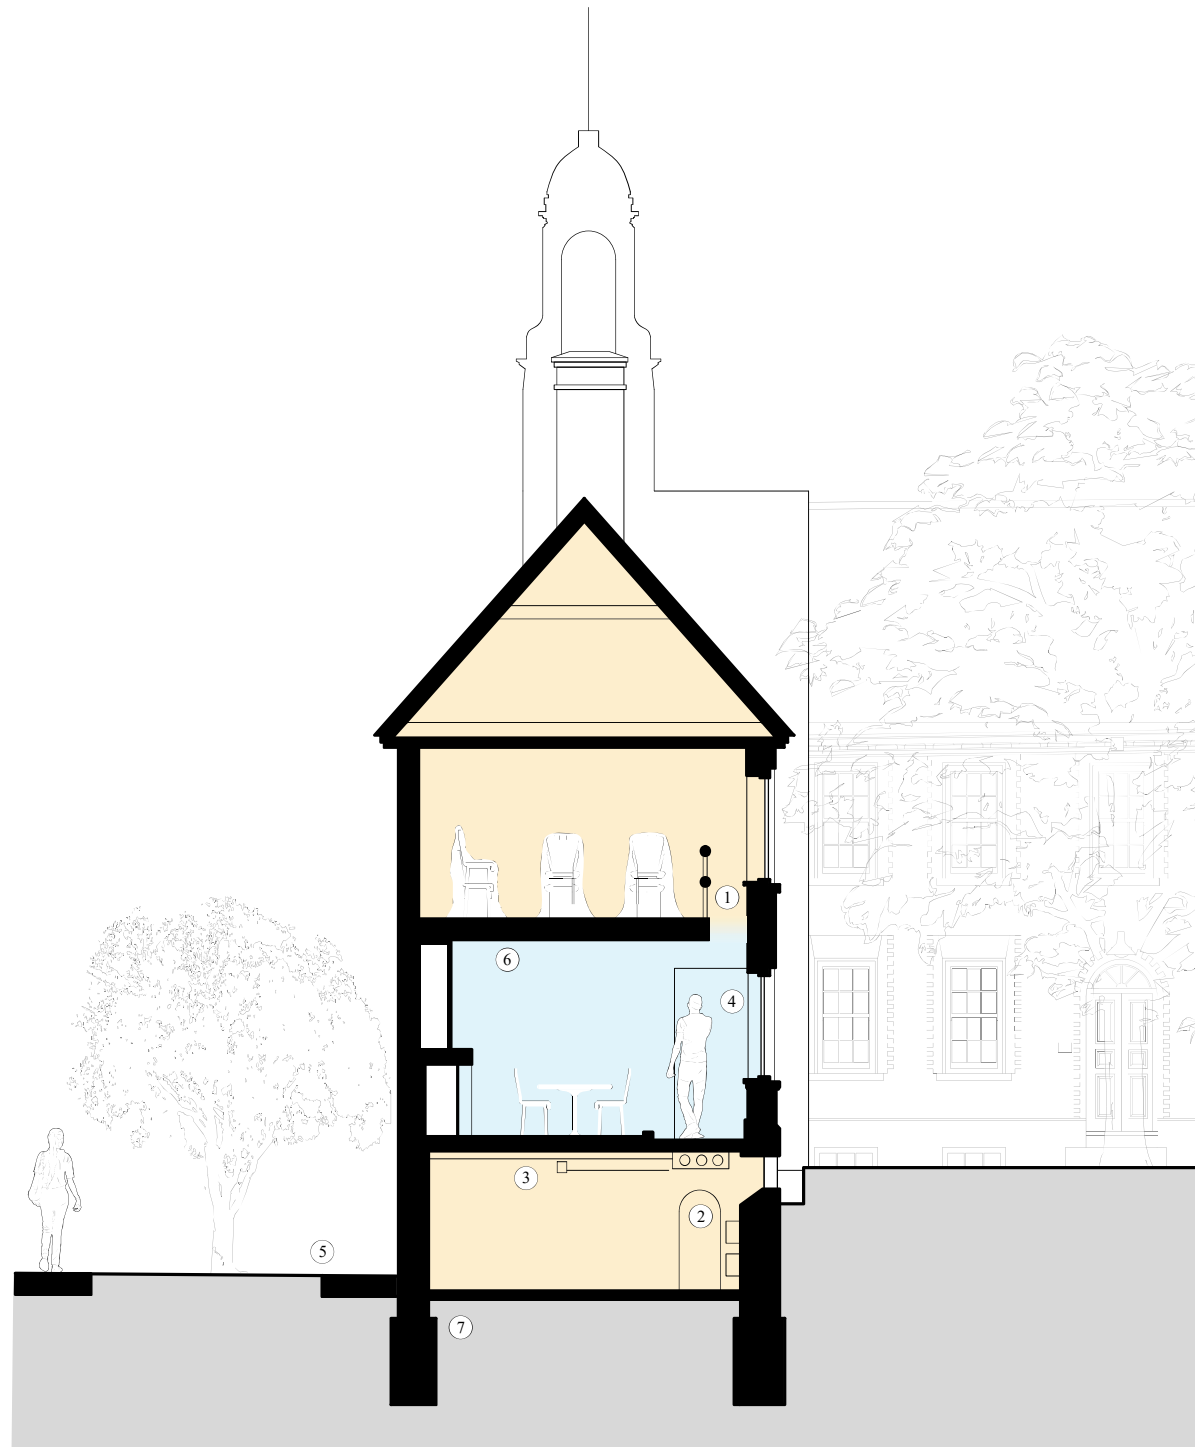
1. First floors do not span front to back and are not easily accessible
2. Front gardens 'made ground' applies surcharge against wall, causing structural cracks around doorways
3. Very low ceiling (1.9m)
4. Leaky building envelope
5. Back garden, natural ground level with narrow paths through gardens
6. Ceiling heights change to reflect the Period Rooms
7. Trial pits indicated external wall foundations have sufficient depth for lower ground floor to be lowered without underpinning.

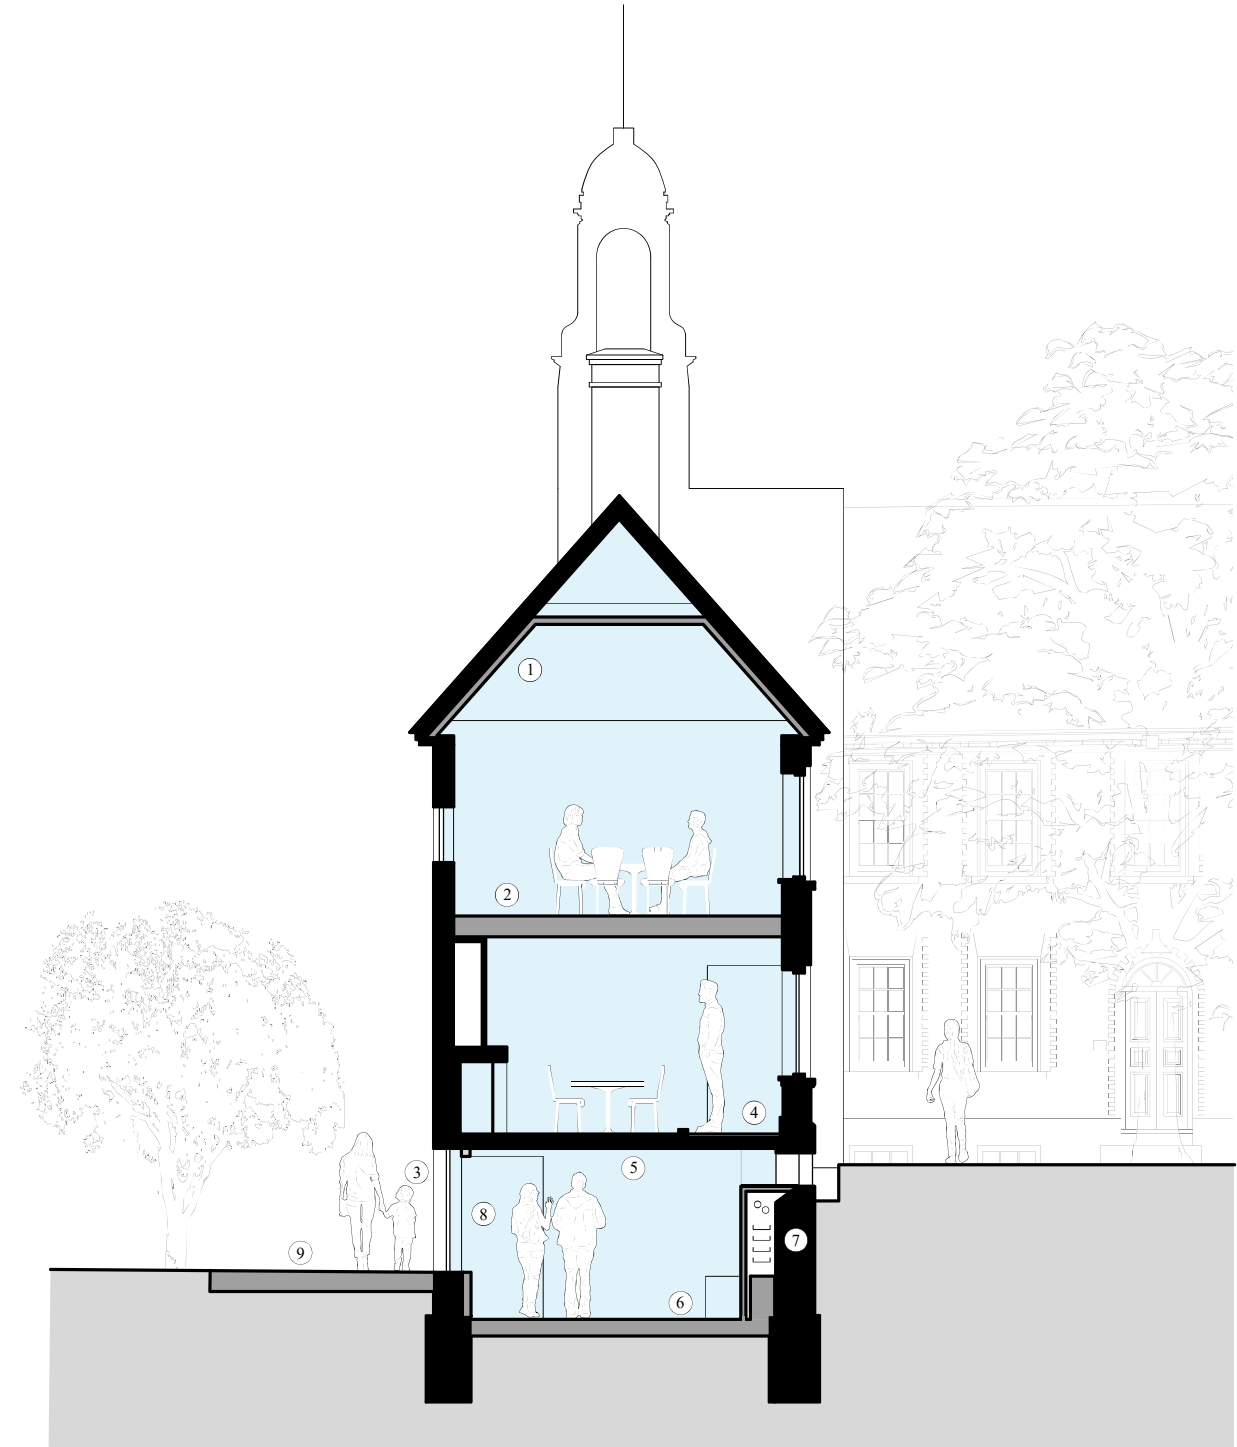
1. First floor ceiling opened up in one house to provide increased space
2. First floor reinstated to stabilise the building and allow the public up to the first floor
3. Previously bricked up windows to rear elevation reopened to allow light in and views out to the gardens
4. Floor finishes added to circulation route to limit acoustic transmission to floor below
5. New ceiling lining added at lower ground floor to improve fire separation
6. Lower ground floor level lowered by 1m to provide increased gallery space
7. Services consolidated behind lining out
8. Previous door openings infilled to alleviate ground pressure and circulation route moved to the other side
9. Garden path widened to improve garden accessibility.
